Product Services Systems and Value Creation. Proceedings of the 6th CIRP Conference on Industrial Product-Service Systems

Service knowledge capture and reuse

Keywords: Service damage identification; degradation analysis; pulsed thermography; non-destructive inspection

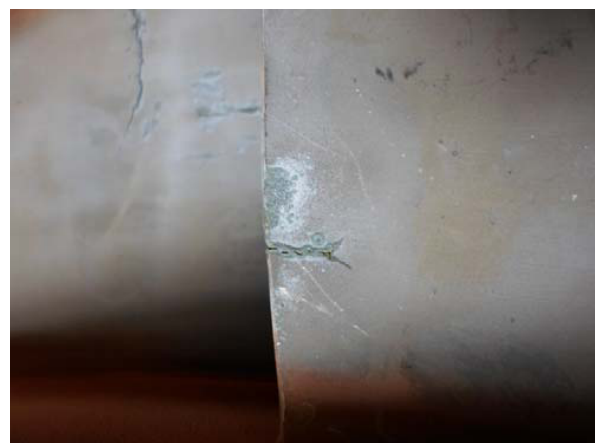
Figure 2: Image of aero-engine component exhibiting typical damage.

The automated knowledge capture approach analyses the thermal images of service damage on a component and verifies the results with other non-destructive testing techniques if appropriate. An integrated system to automate the service damage capture is also developed using a robot. For inaccessible areas, a borescope is designed for railway axle internal service damage examination. From literature it has been noticed that the most common degradation mechanisms for aerospace components are wear, cracking, fatigue, and corrosion (Figure 2).

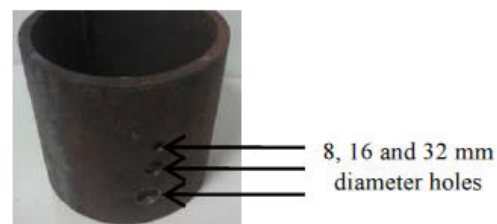
Figure 9: Forged steel round test cylinder.

In order to simulate the axle inside inspection, a 1cm thick steel cylinder was manufactured. This test piece contained holes of different diameters that were machined in the outer surface of the cylinder. The holes are at a depth of 1mm from the inside surface. Two sets of holes were made on the cylinder; one set contained no rust and another with rust. Holes with the same dimensions were made in both parts to see what influence the presence of rust had. The cylinder is

shown in Figure 9. The cylinder is 10mm thick, 200mm long and is 90mm in diameter.
